**MARYLAND HISTORICAL TRUST  
DETERMINATION OF ELIGIBILITY FORM**

Property Name: Baker-Solley Outbuildings Inventory Number: HA-1297  
Address: 3700 Churchville Road City: Aberdeen Zip Code: 21001  
County: Harford County USGS Topographic Map: Aberdeen, Maryland, 1985  
Owner: Leroy Solley - 3700 Churchville Rd, Aberdeen MD 21001 Is the property being evaluated a district? NO  
Tax Parcel Number: 112 Tax Map Number: 51 Tax Account ID Number: 067862  
Project: Adams Property Agency: Federal Communications Commission  
Site visit by MHT Staff: ☒ no ☐ yes Name: \_\_\_\_\_ Date: \_\_\_\_\_  
Is the property located within a historic district? ☐ yes ☒ no

**Property Condition Assessment**  
HA-1297 Baker-Solley Outbuildings  
Aberdeen, MD 21001

HA-1297  
Baker-Solley Outbuildings  
Behind 3700 Churchville Road, Aberdeen  
Aberdeen quad

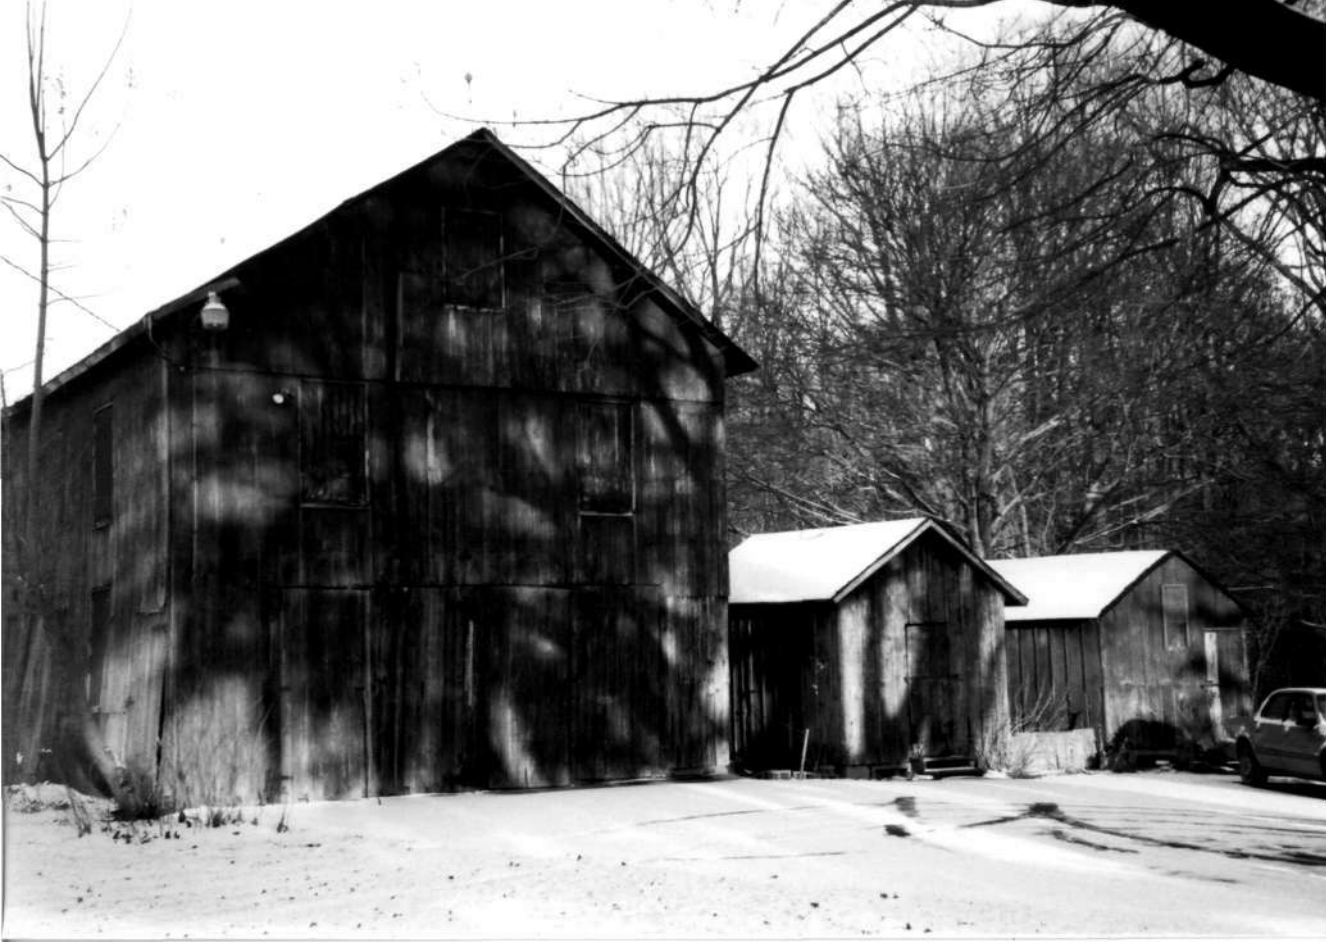
HA-1297

south. The easternmost barn also has a monitor roof. The south side has the main entrance and the west end has entrance wood porticos/porch. Fenestration had been 6/6 sash windows with wood and stone lintels. The windows are presently covered with wood boards. It was observed that, with the exception of the covered windows, this property appears virtually unchanged from the description in the attached form.

SOUTH ELEVATIONS
